WINKFORD FARM, BROOK, GODALMING GU8 5PR  
PROPOSED COUNTRY HOUSE

Design and Access Statement for Waverley Borough Council: VOLUME III - APPENDICES

**ECOLOGICAL ASSESSMENT & BAT SURVEY**

**FARM BUILDINGS AT WINKFORD FARM  
WHITLEY, SURREY**

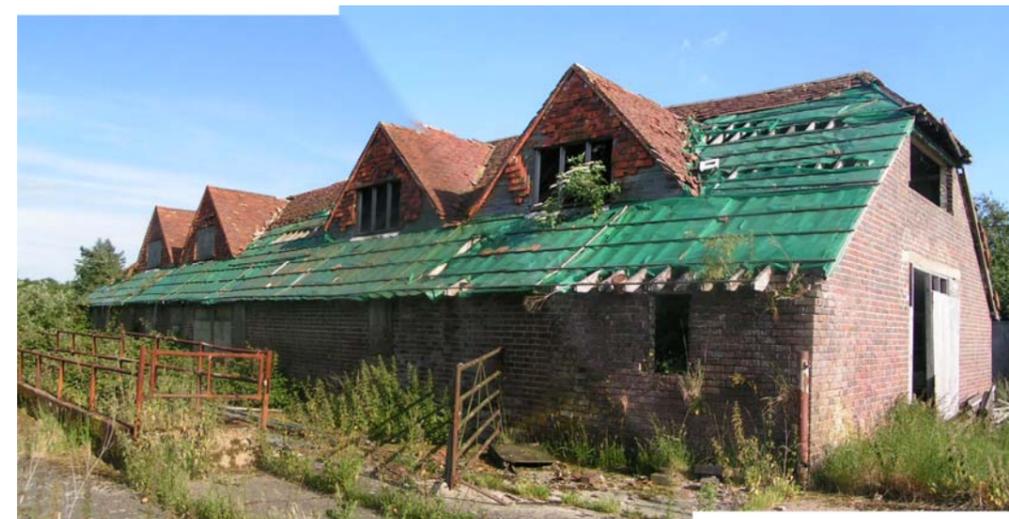
Figure 5. Building 1: Traditional barn – north side.

This building was single storey; except at the east end where there was a former feed store above a milking parlour. The walls were red brick and in comparatively good condition. The roof was small clay tiles, which were missing in many places – sometimes entirely. The tiles were on wood sarking and underlay that were disintegrated or missing and there were relatively recent repairs using plastic sheets. There were no features along the wall tops. The roof frame was collar beams inside that were in good condition. Along both sides of the twin-pitched roof were dormer-style windows – some were boarded-up. On the face of the dormers, around the windows, there were hanging clay tiles (with some tiles missing) on wood weather boards. At the east gable end of the building the wall was a wood frame with horizontal weather boards on a bitumastic underlay over straw and metal sheets – all missing in places. At the west gable end was a hipped roof and open window.

There was good potential for crevice roosting bats behind the hanging tiles on the faces of the dormer windows and behind the weather boards on the east gable end of the building. There was some potential for bats behind the roof tiles.

During the second emergence survey, one common pipistrelle (*Pipistrellus pipistrellus*) was seen to fly from the east gable end of the building. The location of the roost was confirmed during the dawn survey: two common pipistrelle entered a gap to behind the weather boards (Figure 11). There were no signs found of bats inside the building, which was light and airy inside.

- **Alternative roosts are put in place for the bats for at least the duration of the demolition and refurbishment works and ideally retained post-refurbishment. Ideally, these to be retained in the long term. For example, the erecting of bat boxes throughout the site. It is recommended that the boxes be put in place ASAP, which will give the bats time to find and use them before the works. This will increase the likelihood of them being used.**

- **A procedure be in place to check for and exclude and/or rescue any bats present during demolition.**
- **Replacement roosts are created in the refurbished building. This should be the protection or re-creation of the existing roost, in exactly the same position, and, as compensation for the loss of other potential roosting crevices, the re-creation of gaps into the roof structure of the framed barn as potential bat roosts and behind the hanging tiles on the traditional barn. Access gaps to be 5cm wide and 1.8cm high at the entrance leading directly in to the cavities/spaces.**

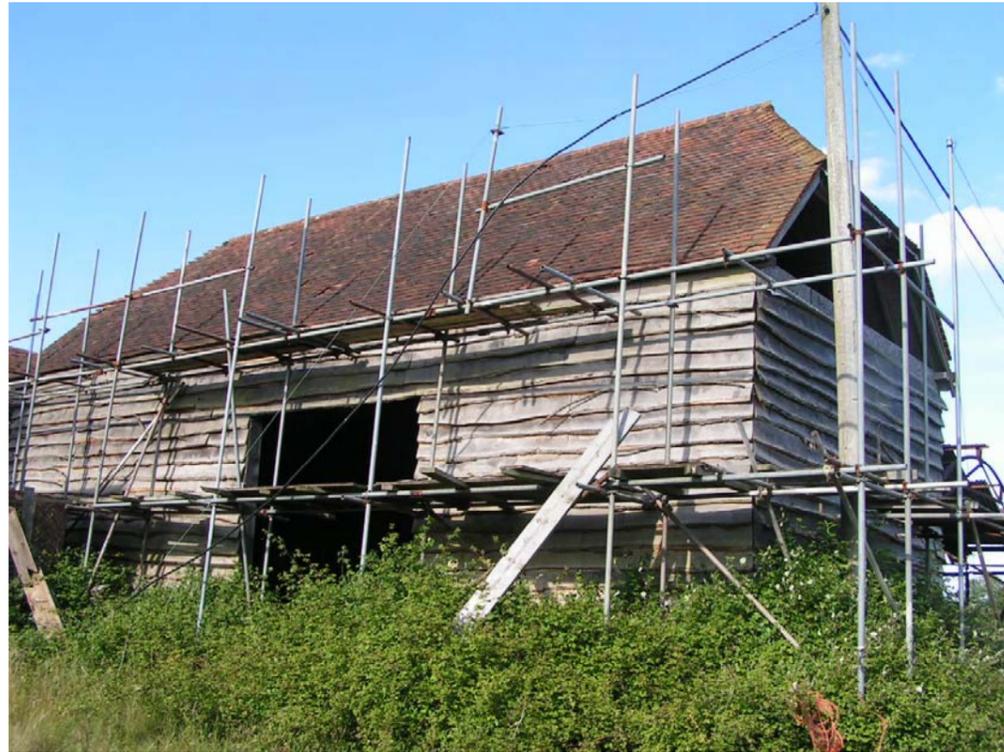
Figure 6. Building 2: Wood-framed barn – south-west side.

This building was a two storey barn, inside of which was a single space. The building appeared to have been partly restored a few years ago. The walls were horizontal weather boards over wood chipboard panels on the inside that were in comparatively good condition but with some gaps between boards. The roof was small clay tiles on wood chipboard sarking. It was in good condition; there were some gaps between tiles and missing tiles. It had hipped ends. The wood frame inside the building had several crevices in it at open mortise joints. These were shallow and could be checked using binoculars and a high power torch. There were two open doorways on both sides and a large opening at the top of the south gable end.

There was good potential for crevice roosting bats behind the weather boards and below the tiles. It was considered too light and airy inside for bats to roost in the open.

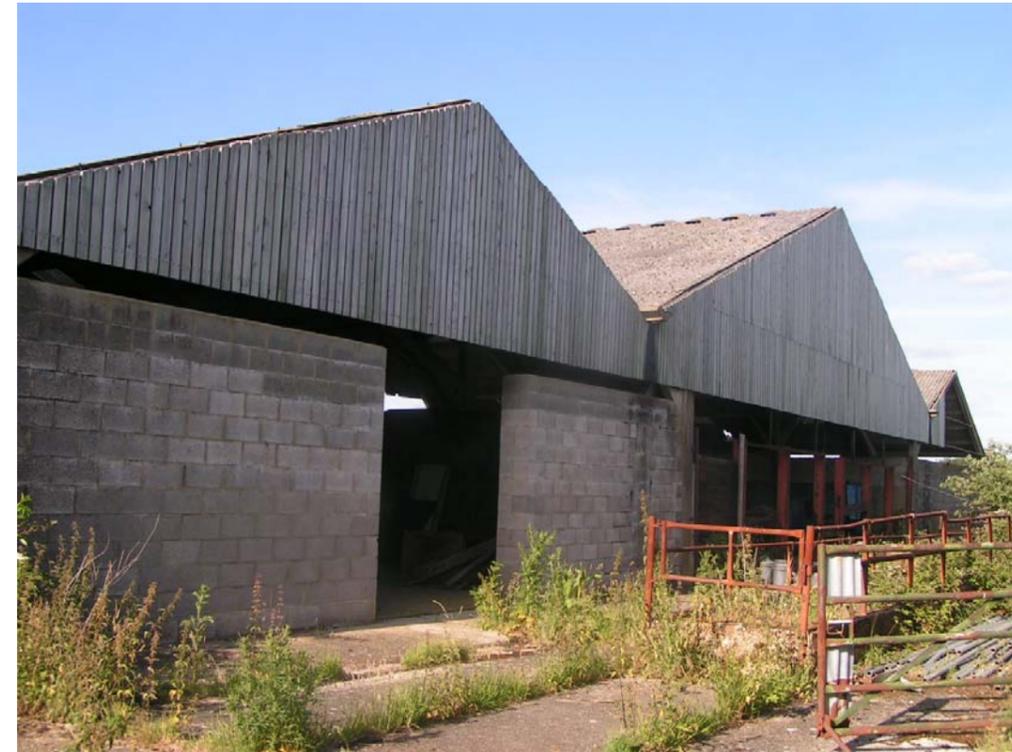
Figure 7. Building 3: metal-framed barns – south side.

These were three large, relatively modern, abutting, metal-framed barns. They had single-skinned walls of breeze blocks to eaves height. Large openings at one or both ends. Above eaves height on the gable ends were a mix of vertical, hit-and-miss wood slats and corrugated sheets. The roofs were a single skin of corrugated sheets on the metal frame. Light and airy inside.

Negligible.

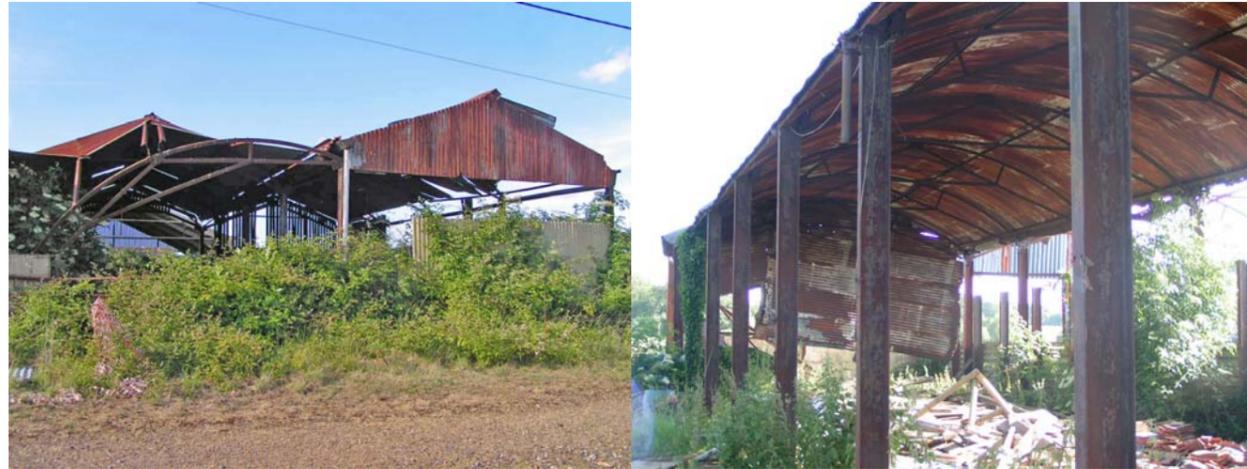
Figure 8. Buildings 4 & 5 Derelict metal barns.

These were two separate sets of metal-framed, Dutch-style barns. The walls and roofs were largely missing; those that remained were single-skins of corrugated sheets. Open to the elements inside.

None.

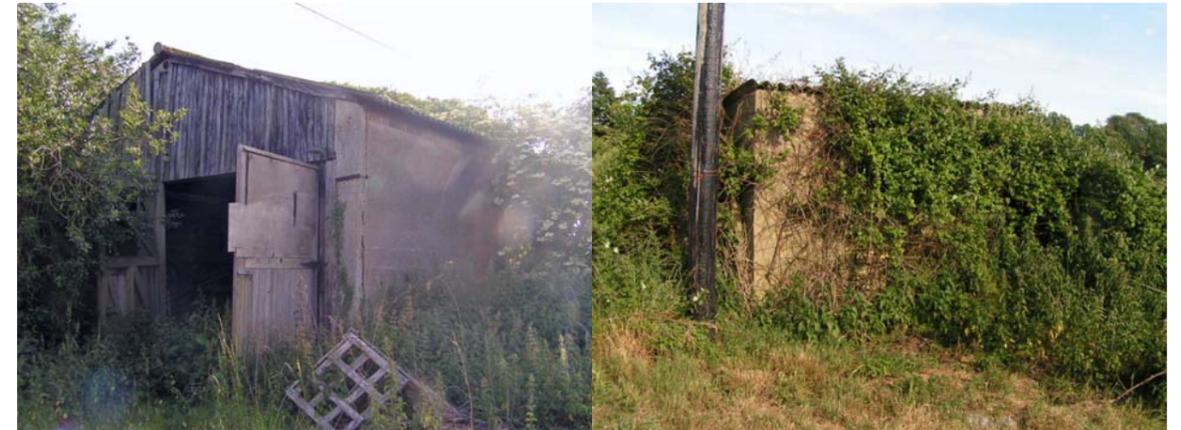
Figure 9. Buildings 6 & 7: Stores.

These were two separate stores. Building 6 was a large store/garage with a dual-pitched roof of corrugated sheets and rendered walls. There was a large, open doorway with wood slats above eaves height. Building 7 was a smaller concrete shed with a flat, corrugated roof and was clad in vegetation.

Building 6 had a low potential for roosting bats and no signs of them were found. Building 7 had negligible potential for roosting bats; it could not be entered by the surveyor.

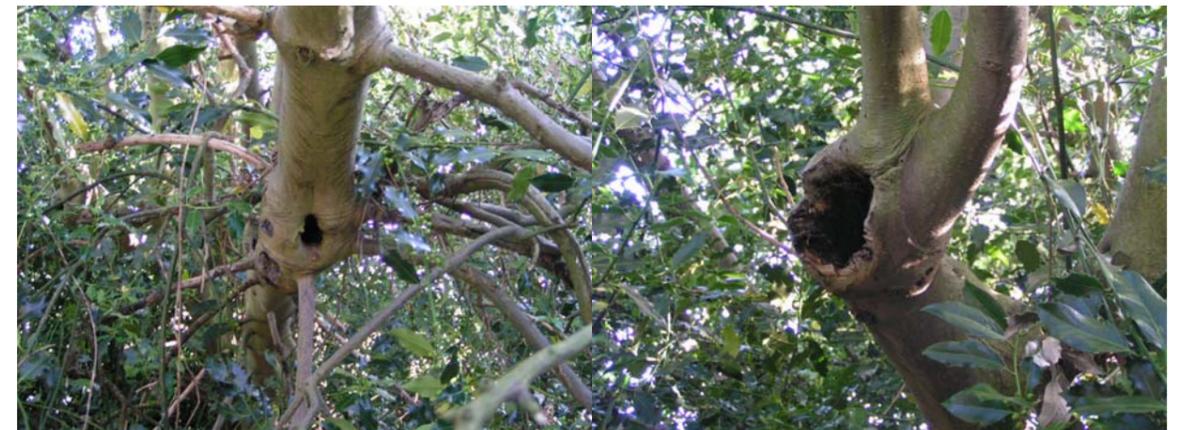
Figure 10. Potential bat roost hole in holly trees.

One of the holly trees on the south-west edge of the site next to Building 6 had good potential for roosting bats. This potential was in two holes in branches. Both holes were approximately 1.5m from the ground. They were 10cm+ deep, extending in to the branches. They were shaded from the sun, due to being under the canopy of the trees.

None, both holes were checked using an endoscope and during the night-time surveys.

- **It is recommended that the branches in the holly trees that contain suitable holes for roosting bats are retained and protected, including not lit at night.**

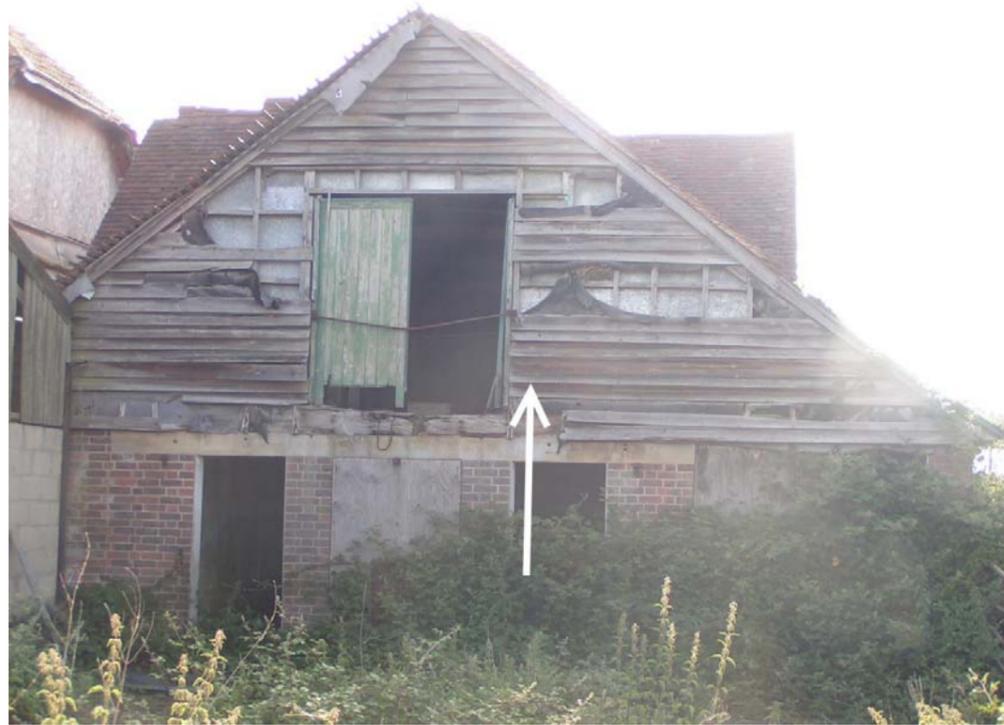
**Figure 11.** Location of common pipistrelle roost

Elsewhere at Winkford Farm, there are numerous possible gaps for crevice roosting bats in the traditional and framed-barns but this is constrained by the isolated and exposed position of the site.

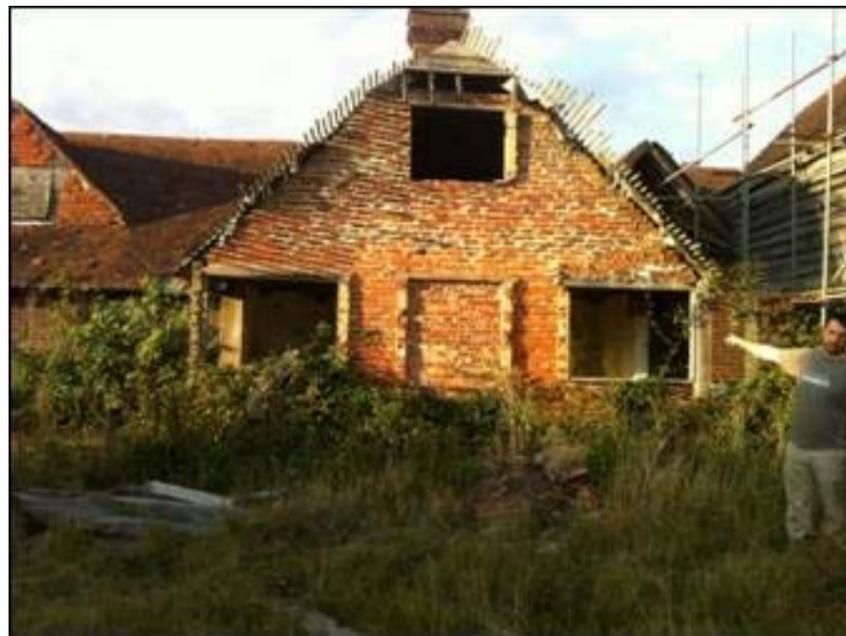
Figure 2. Building 1, south gable showing collapsed external wall.

The south gable end of the cow shed has collapsed; originally this was composed of two back to back brick walls with a 50 mm cavity between them. The external herringbone wall has fallen away leaving the internal wall exposed (Figure 2).

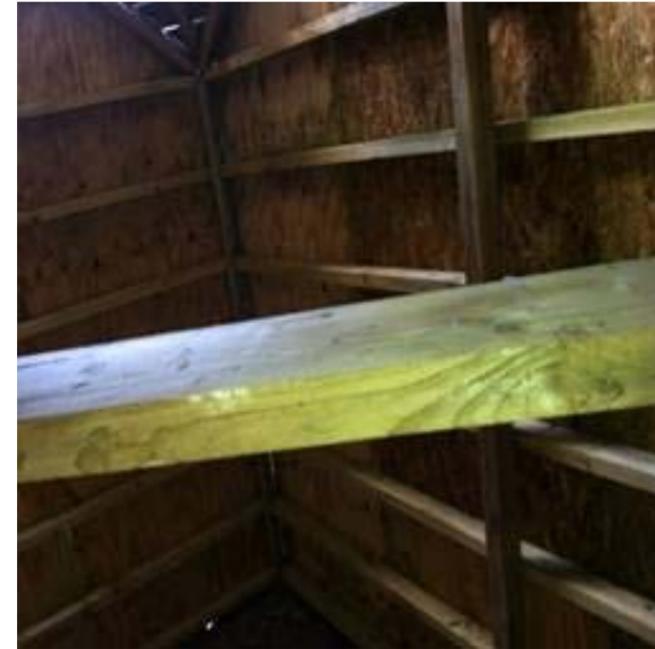
Figure 3. Building 1, hardboard roof and light interior.

This missing tiles on the south facing gable end have been replaced with hardboard (Figure 3), and three openings result in the internal aspect of this part of the building being very light and draughty: there was no evidence of bats using this part of the building.

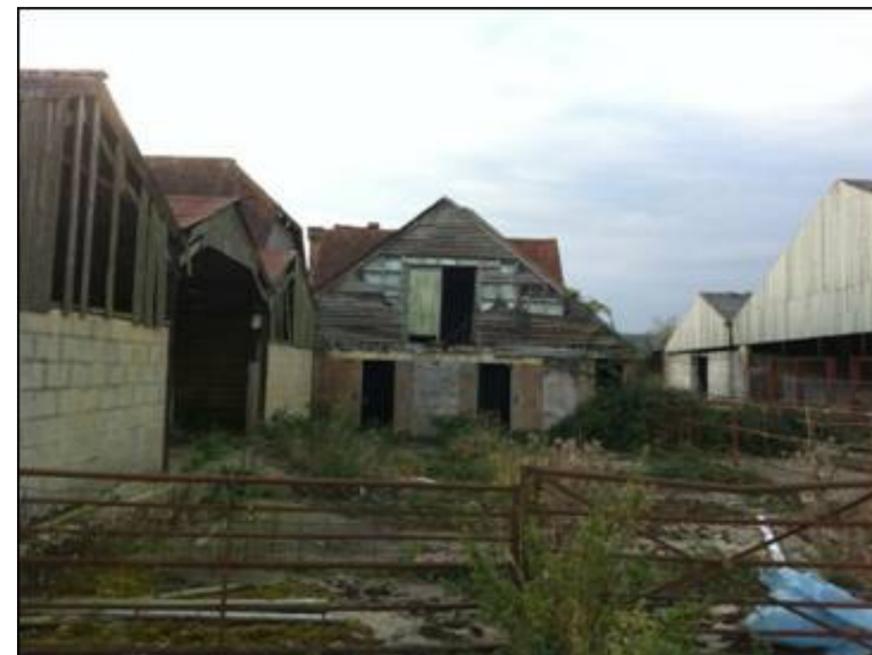
Figure 4. Building 1, east gable end.

Figure 4 shows the east facing gable end of Building 1. This is the location of the pipistrelle roost recorded in 2010. Considerably more of the timber cladding has fallen away since the previous survey was carried out revealing the metal sheeting behind and reducing the roosting opportunities for bats (Figure 5). **During the emergence survey no bats were seen to leave from this aspect of the building.**

This update survey indicates that the east end wall of the brick cow shed (Building 1) where the bats roosted in 2010 has deteriorated and may no longer be suitable for roosting bats; although old bat droppings occur here and it is possible that bats may be familiar with and still occasionally roost here.

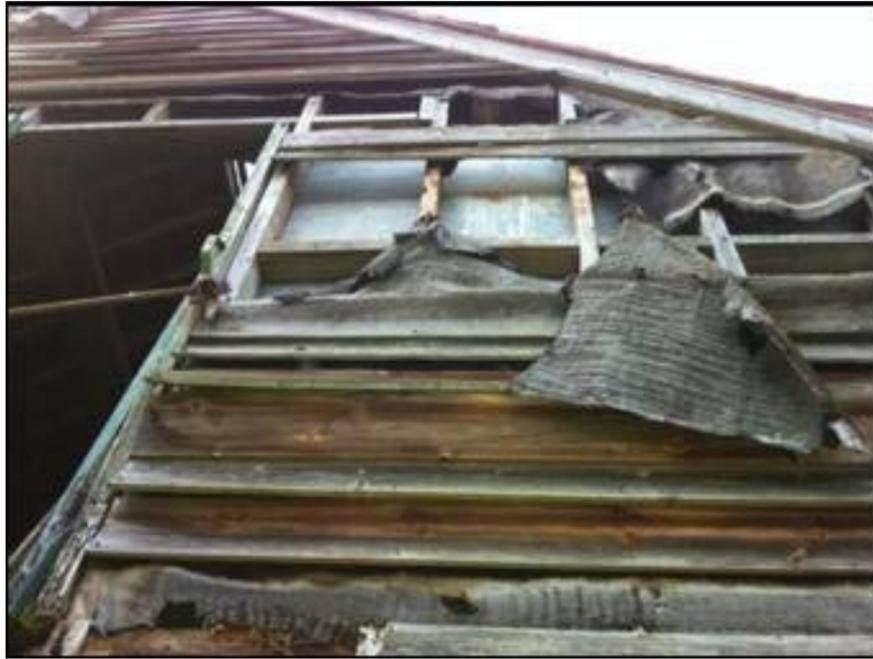
Figure 5. Building 1, location of pipistrelle roost in 2010 pictured in 2012..

A search revealed **bat droppings (< 20)** on the left hand side wall. These looked quite old.

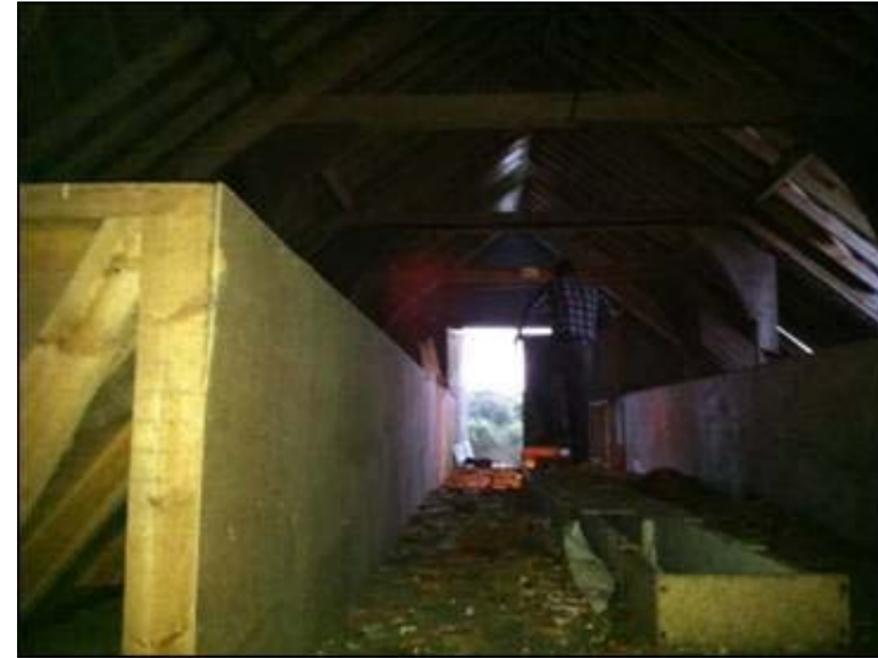
Figure 7. Building 1, interior of first floor at east gable end.

No evidence of bats was recorded in the first floor area, which was quite light due the opening at the end of the building.

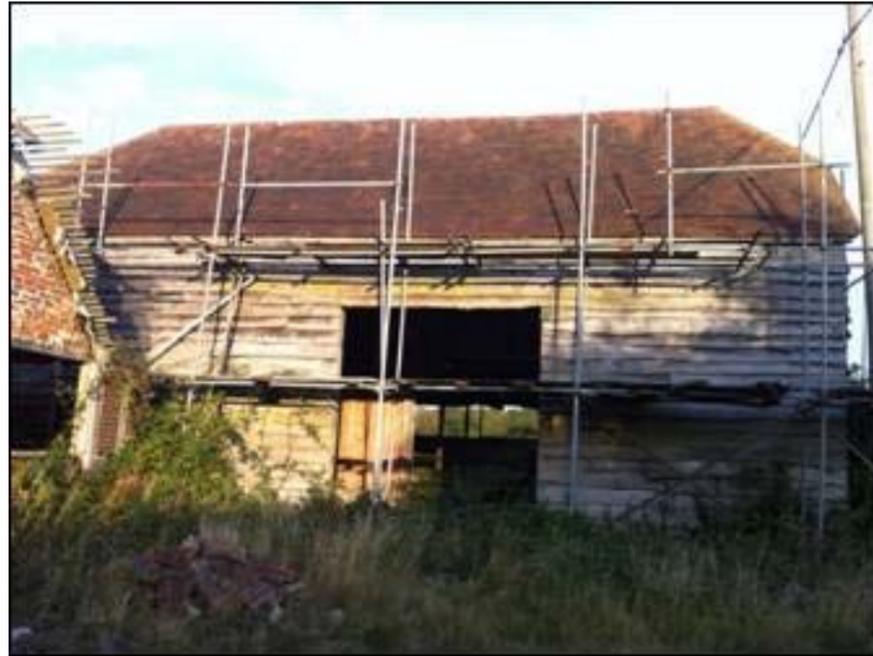
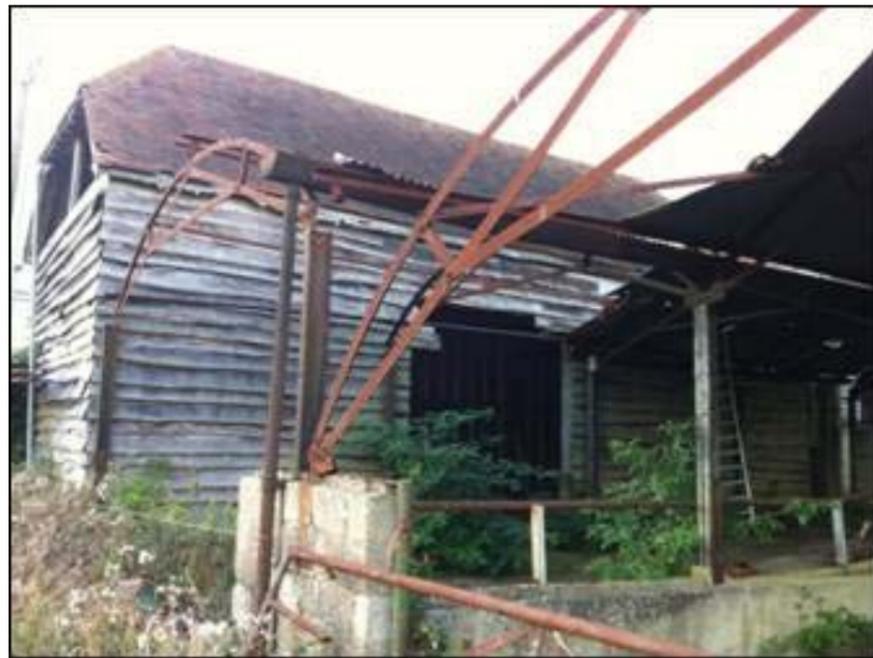
Three large open doorways (Figures 8 & 9) to the barn mean that it is fairly light inside, it is however darker at the rear end. **Bat droppings (<10) were found on timber planks below the ridge beam at the far end of the barn.** Some of the droppings were fresh and some looked older. Judging by their size the droppings were from two different species of bat, the smaller ones where thought to be pipistrelle droppings and the others were large. The internal aspect of the barn was clad in hardboard and due to the paucity of cracks or small gaps/holes offered what appeared to be little or no roosting opportunities to crevice dwelling bats. No bats were discovered in the barn during the building survey.

Figure 8. Building 2, west aspect.

Figure 9. Building 2, east aspect and warped boards.

- Work affecting bats and their roosts to ideally also avoid mid – late September.
- Replacement roosts to include those that are suitable for the larger noctules. This can be as part of the external structure of the barn (i.e. it need not affect proposals for its interior).

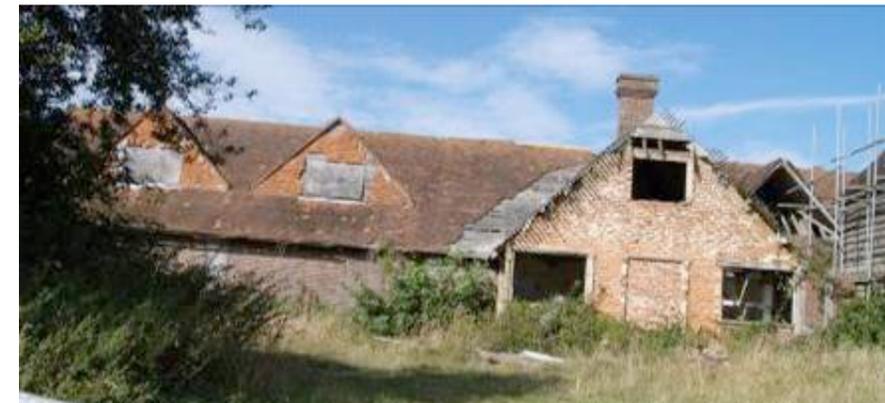
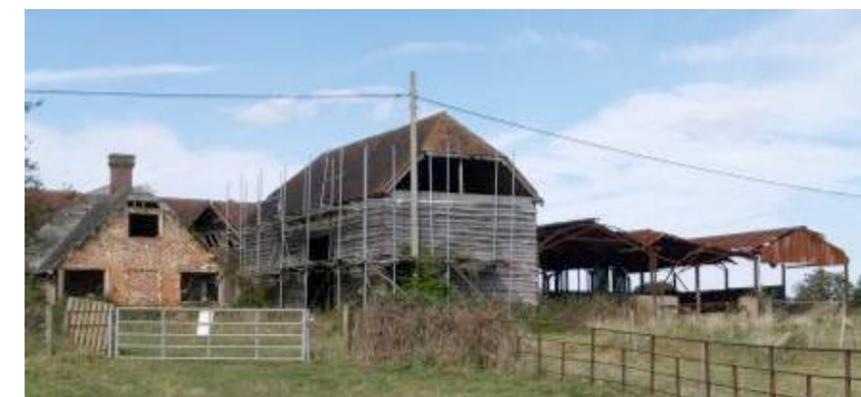
*Photographs of buildings to be retained and refurbished*

2.05 The farm buildings on site are currently disused and are generally in a dilapidated state. The buildings are substantial and range from more traditional brick built structures to modern barn types. The traditional farm buildings lie in a central position and have been used in the past for cattle and agricultural storage. The cattle shed / milking parlour is a one and a half storey building, constructed in brick with clay roof tiles. The traditional barn located alongside the cattle shed is timber framed and externally clad in weatherboarding with clay roof tiles. It is these buildings which are proposed to be retained and converted. The photographs below show these structures.

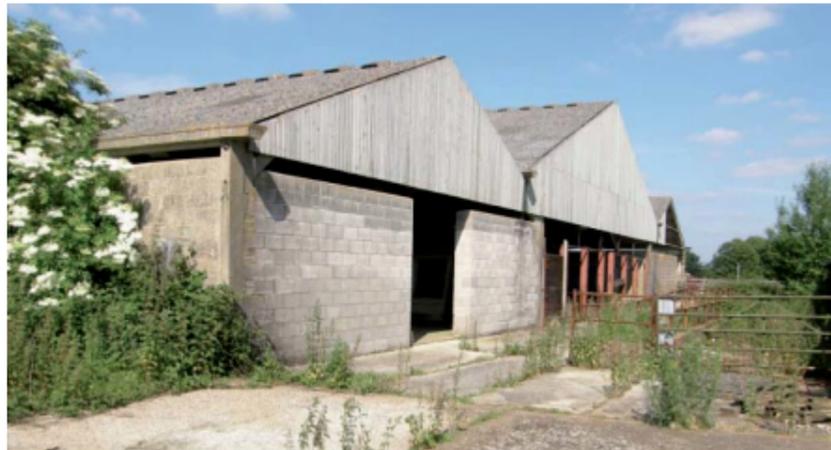
*Photograph of buildings to be removed*

2.08 Overall this is a typical group of farm buildings comprising a mix of agricultural 'cheaply' built and very bulky structures. The photograph below illustrates the condition of some of the existing substantial barns on the property.

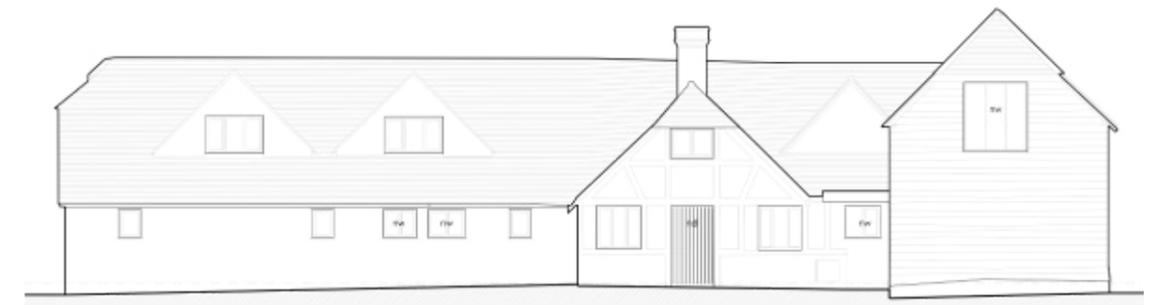
*Elevation of Principal Barn*

4.11 The principal barn (referred to as house & cattle shed on the submitted plans) is to be retained and the proposed change of use will extend to conversion and repair works, whereby all openings will remain as existing and all materials used will match the existing.

4.12 The appearance of the brick and timber building will be improved and includes the retiling of the roof. The external appearance of the barn is shown below.

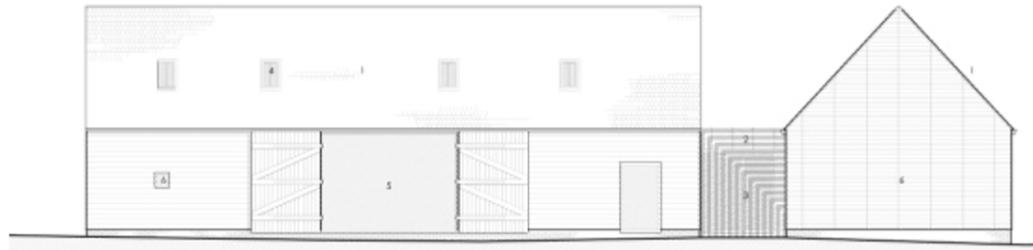
*South elevation of proposed new timber barn*

4.14 The barn to be demolished lies adjacent to the principal barn and the existing (to be removed) large corrugated iron clad barns. The proposed replacement structure will be of a traditional barn style not dissimilar to part of the existing timber barn being converted. This will be timber clad with a clay tile roof. The proposed materials will match that of the principal barn. The south elevation of the building is shown below.
